**Oran Park
Oran Park**

40740

February 2007

Client: Growth Centres Commission **Project Number:** 40740
Project: Stage 1 Contamination Assessment **Date:** 18/01/07
Location: Oran Park **Logged:** AT

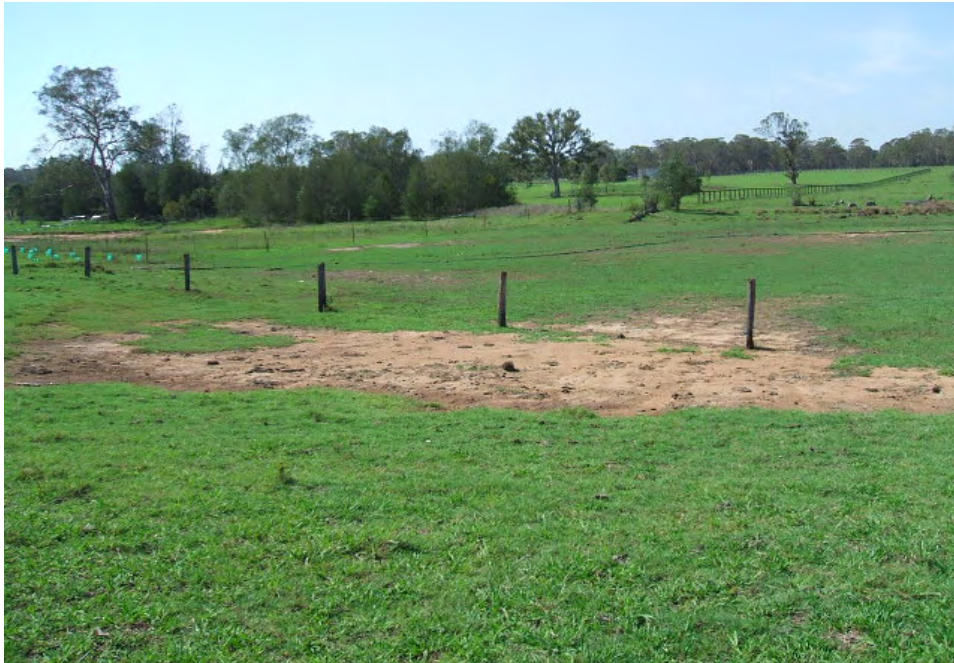
Photograph 7: PAEC 46 Stripped surface (no fill)

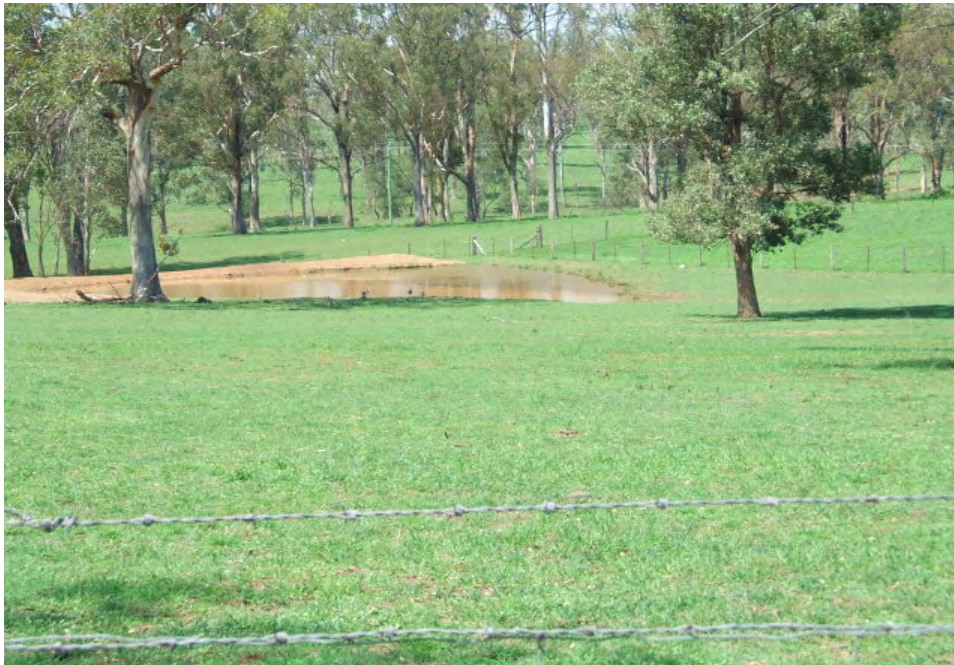
Photograph 8: Farm dams are constructed of locally won material

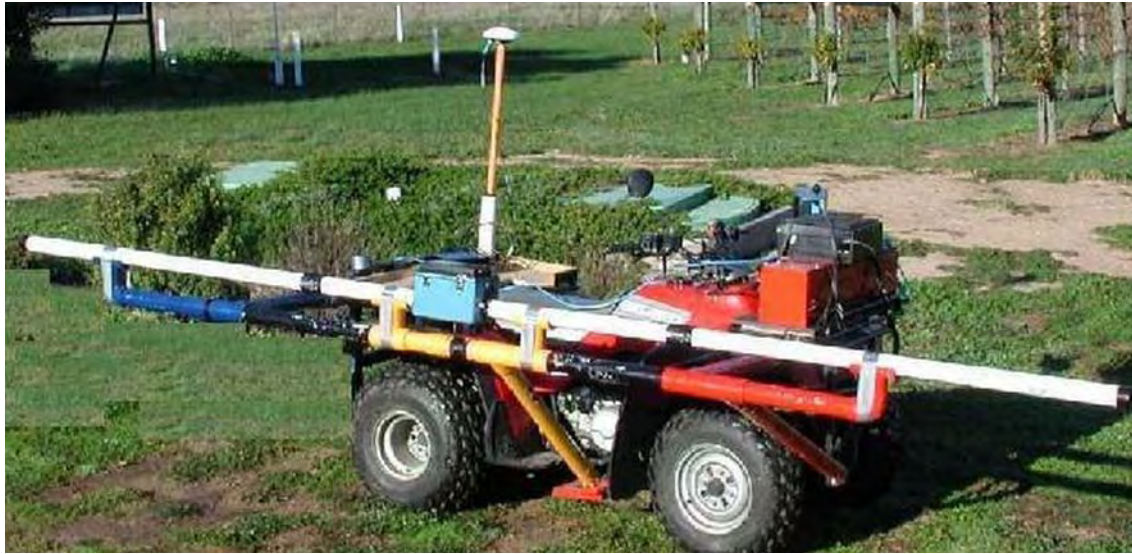
The EM31 was mounted 1 m above ground surface in a non-conductive frame cantilevered 0.5 m from the side of the quad bike and was operated in the vertical dipole (horizontal coil) mode with a coil separation of 4 m, for a maximum depth of investigation of approximately 6 m. The photograph below shows a system similar to that used on this project.

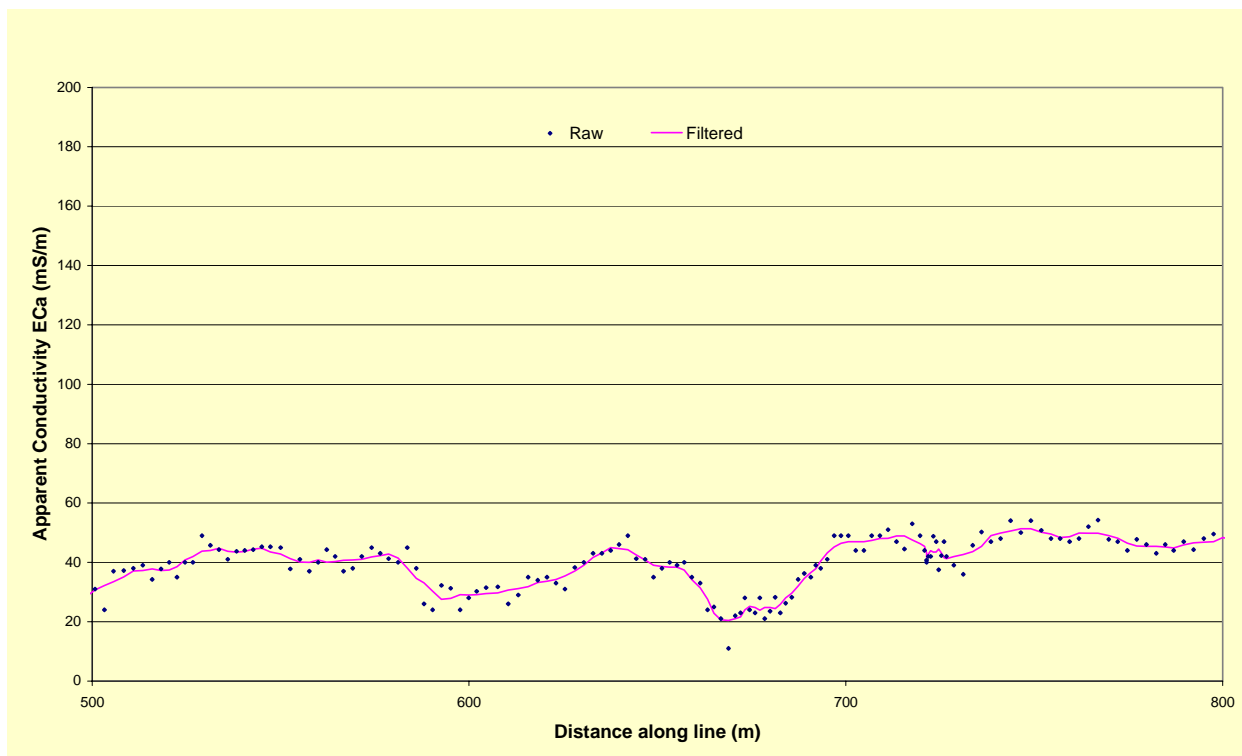
Figure 1 below shows a typical ECa profile obtained from the ATV. Raw data shows apparent conductivity anomalies with a superimposed noise envelope of ± 5 mS/m (± 0.05 dS/m) due to bumping and vertical movement of the quad bike and EM31 coils. Although this noise envelope is of small amplitude, all data were filtered with a 5-point running average prior to further processing.

Figure 1 – Section of EM31 Profile, Oran Park Precinct

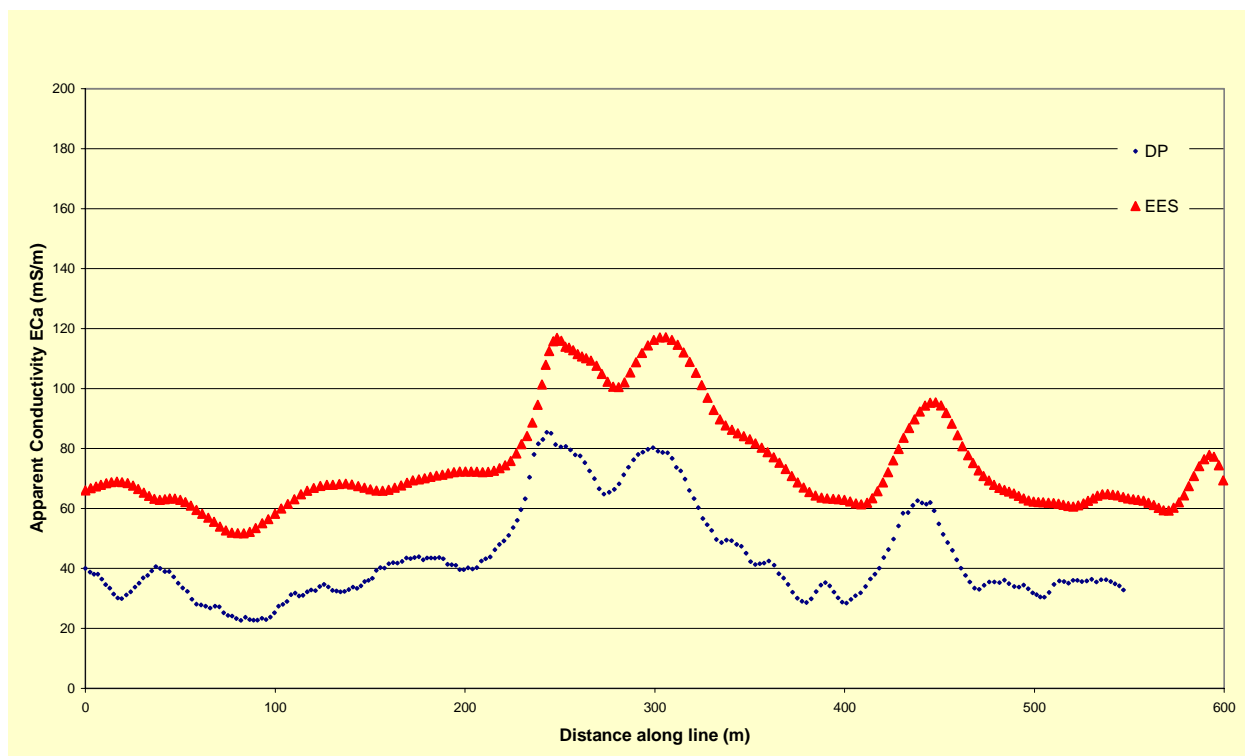
Filtered ECa data from the investigation by Douglas Partners (DP), predominantly from west of The Northern Road, together with data from a previous investigation by Environmental & Earth Sciences (EES) east of the Northern Road, were combined after comparison of values along a “check line” in the centre of the area (Drawing S1) and application of a bulk shift of 35 mS/m to all DP data. This difference can easily be attributed to different vehicle corrections, different moisture contents at the two survey times and differences in instrument height. Figure 2 shows the similarity of the DP and EES data along the check line.

Figure 2 – DP and EES Apparent Conductivity data along check line (looking north)

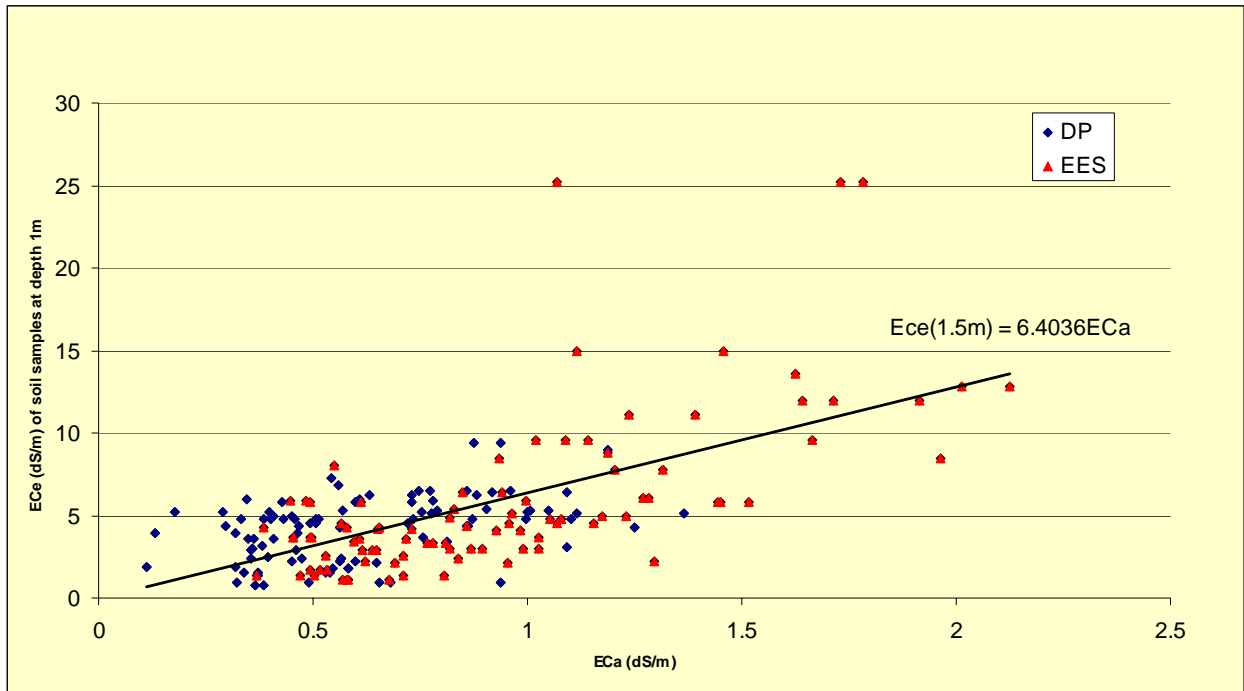
For this correlation (Figure 3 below), all measured ECe values from soil samples at depths of the order of 1.5 m (1.3 – 1.7 m) were plotted on a scattergram against apparent conductivities from the EM31 measurement point closest to the relevant test pit. This sample depth was selected after observation of vertical soil salinity profiles from five control test pits, sampled at 0.25m intervals, showing maximum salinities generally at depths of the order of 1.5 m hence likely to contribute most of the EM31 volume response. Correlations were made between 185 ECa and ECe data pairs, with many of the 176 test pits in reasonable proximity to multiple profiles.

Figure 3 – Correlation of Salinities with Apparent Conductivities, Oran Park Precinct

The general linear relationship between ECe and ECa indicates that the EM31 system was responding to soil salinity. The linear regression performed on the scattergram indicates a factor of 6.4 by which to multiply apparent conductivities (in dS/m) to estimate ECe values throughout the EM31 data set.
